The primary objective of this project was to determine the condition of the two World Trade Center (WTC) towers immediately following the aircraft impacts. This assessment includes both the determination of the structural damage that degraded their strength and the condition and position of nonstructural contents such as partitions, workstations, aircraft fuel, and other debris that influenced the behavior of the subsequent fires in the towers. The global impact analyses were the primary method by which most of the information on the tower damage was obtained. The analyses described in the other chapters of this report, such as the component and subassembly impact analyses, were performed to support the development and validation of these global impact models.

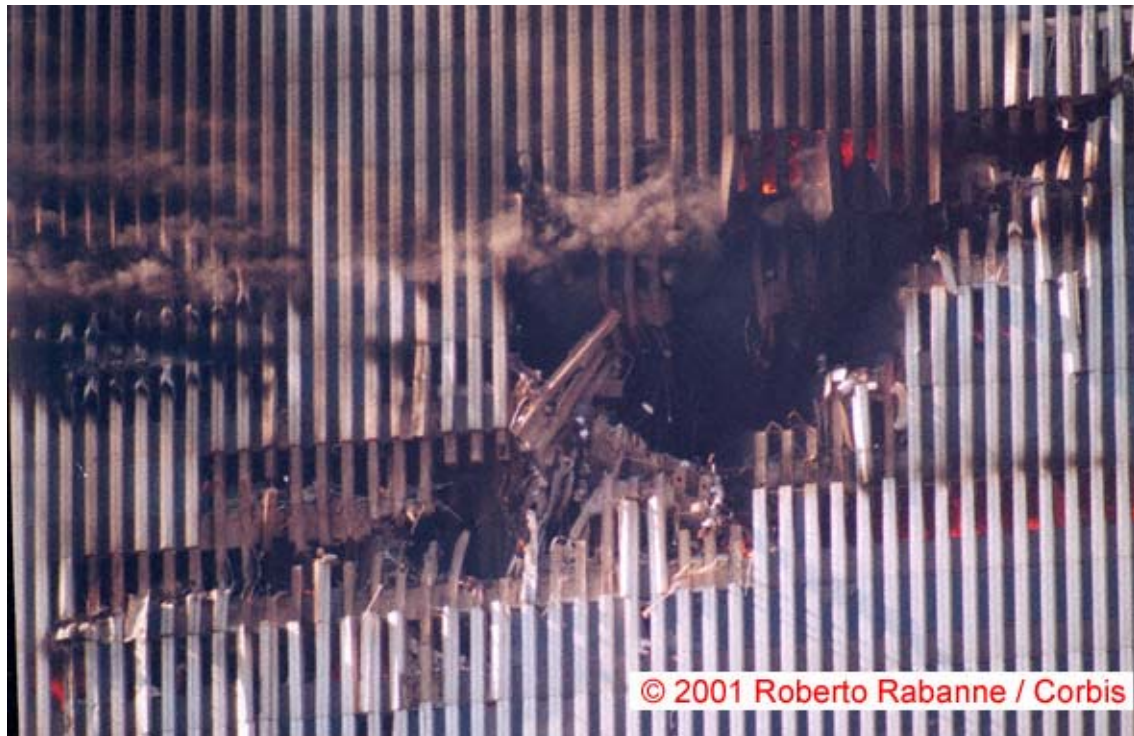
(a) Damage photograph

(b) Calculated damage
